Physical System Dynamics and White Phosphorus Fate and Transport, 1994, Eagle River Flats, Fort Richardson, Alaska

Daniel E. Lawson, Lewis E. Hunter, Susan R. Bigl,
Beth M. Nadeau, Patricia B. Weyrick and John H. Bodette

August 1996

CRREL Report 96-9

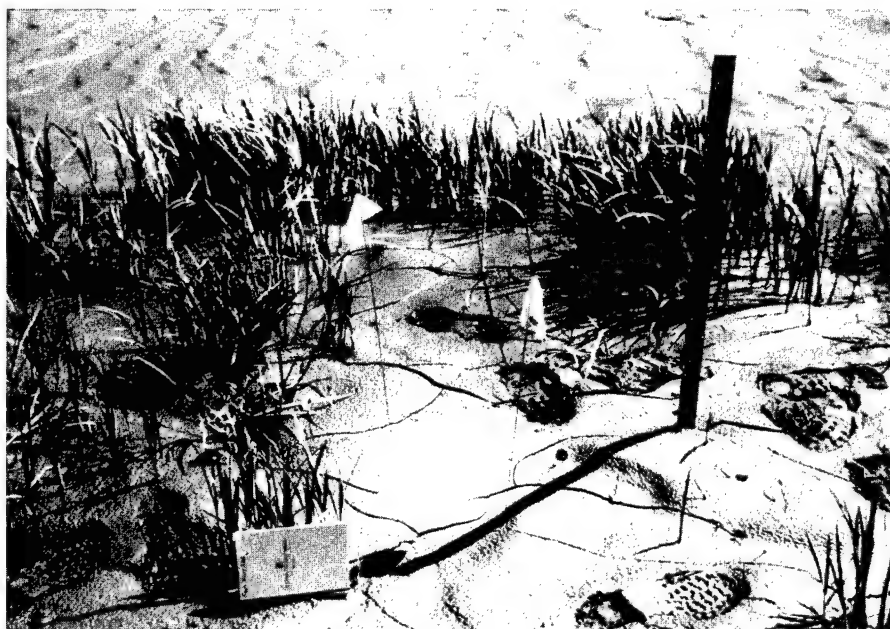
a. Sedimentation stake with plate that slides freely on the rod.

Figure 8. Sedimentation measurement techniques.

b. Wire flags mark an area of painted ground.

We used "sedimentation stakes" to measure erosion and deposition at transect points where the surface was wet or standing water was present (Fig. 8). These stakes consist of a rod and a square, rigid plate (about 7 cm²) that slides freely on the rod as used by Ovenshine et al. (1976a,b) in Turnagain Arm, Alaska. Erosion depth is defined by the increase in distance between the top of the rod and the top of the plate, as measured periodi-

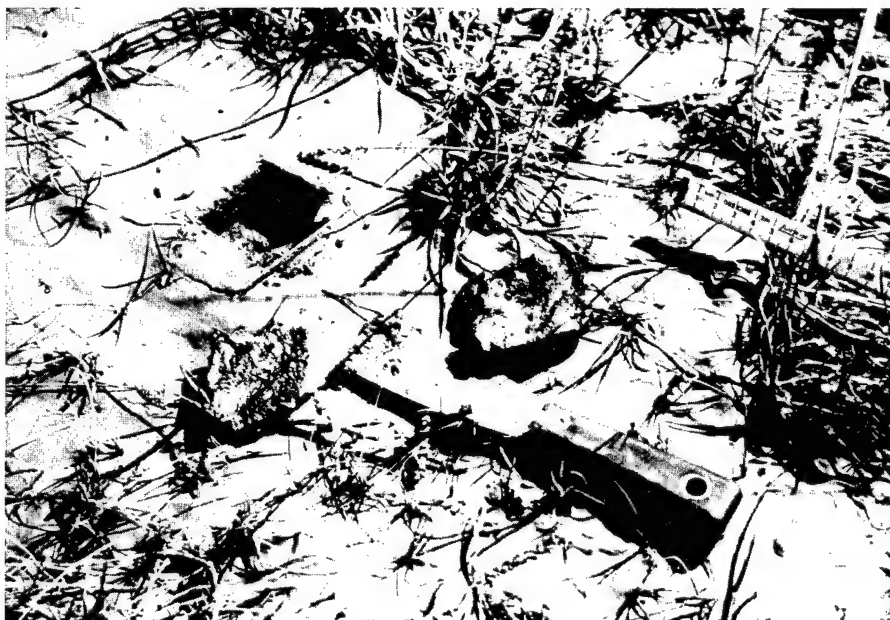
Figure 9. Paint layer depth within block of sediment is measured to define sedimentation rates.

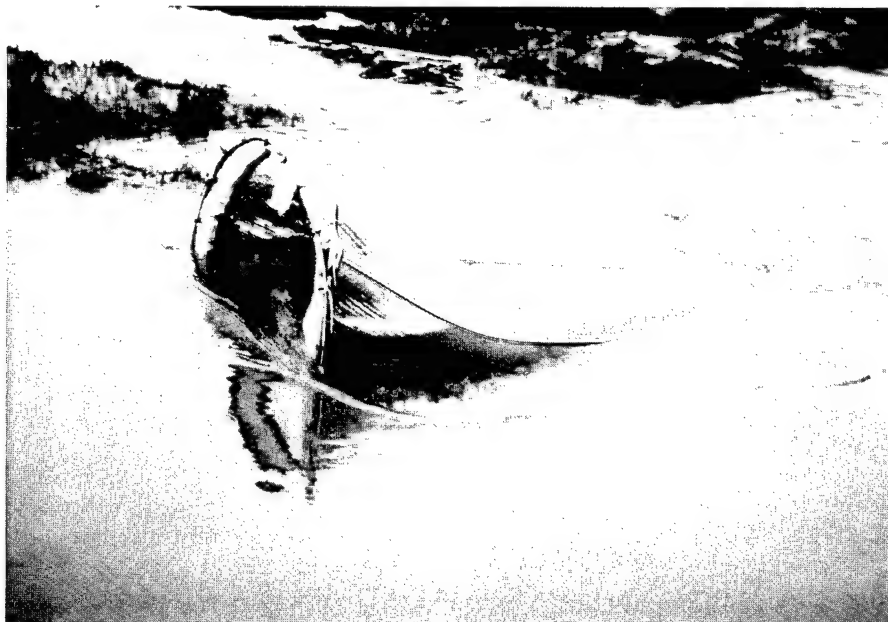
Figure 20. Plankton net used for collection of WP in transport through gullies.

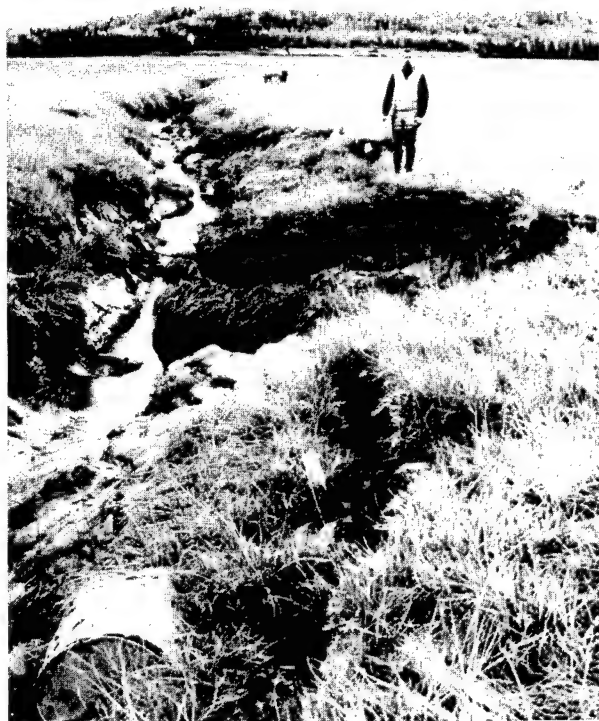
Figure 52. Eastward view of eroded cusped embayment at monitored section of B-Gully where white phosphorus was recorded in transport.

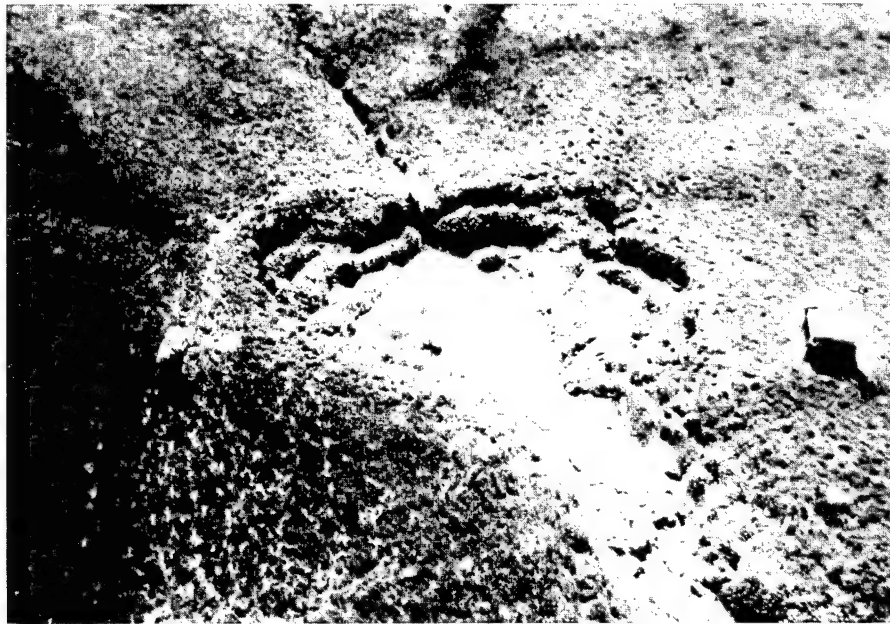
a. Plunge pool of Mortar Gully.

b. Gully scarp of Coastal 6 Gully.

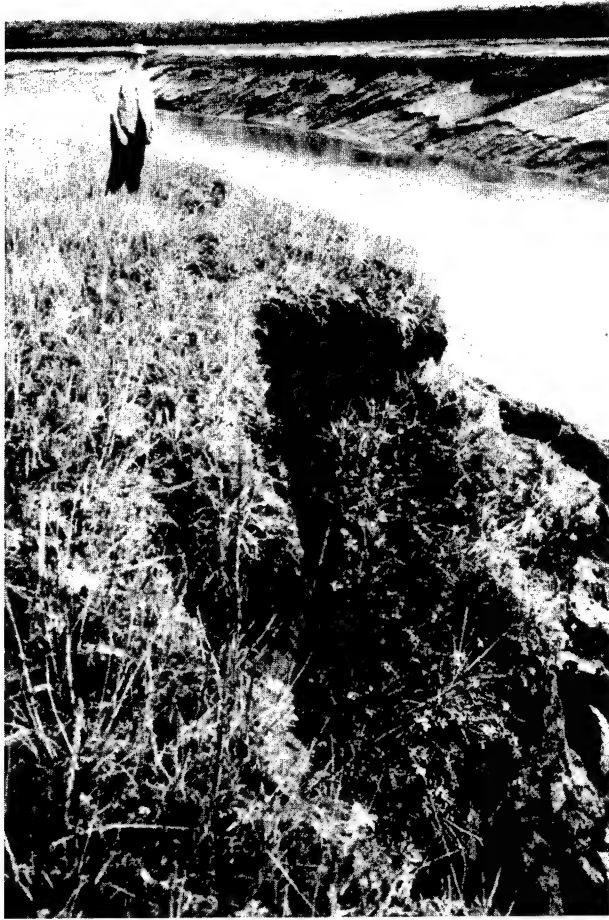
Figure 54. Rotational slump block failure at River Section-North.

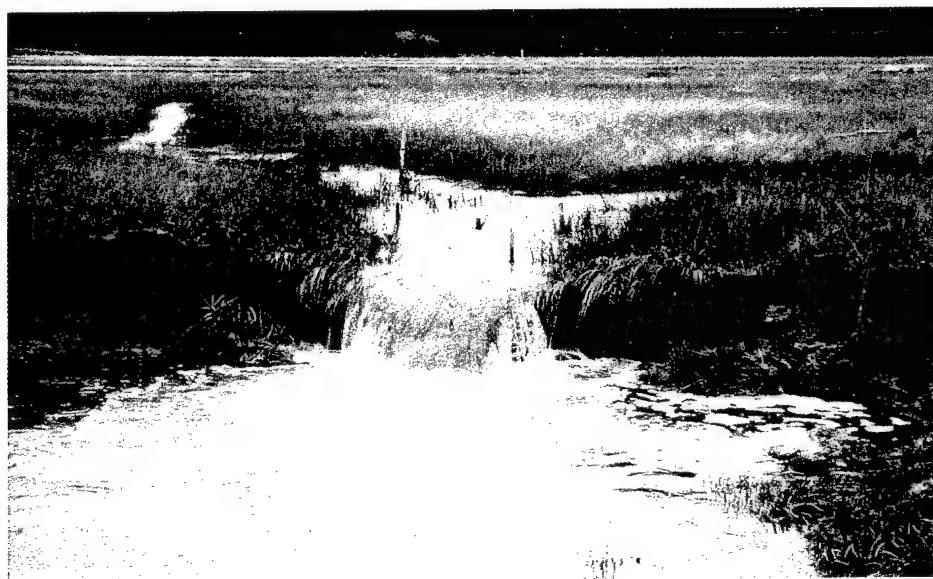
Figure 57. Water flowing over gully headwall at Parachute Gully plunge pool.
